Test Report

Description: Mobile Data Terminal

Model/Type: C71

- I Drop Test

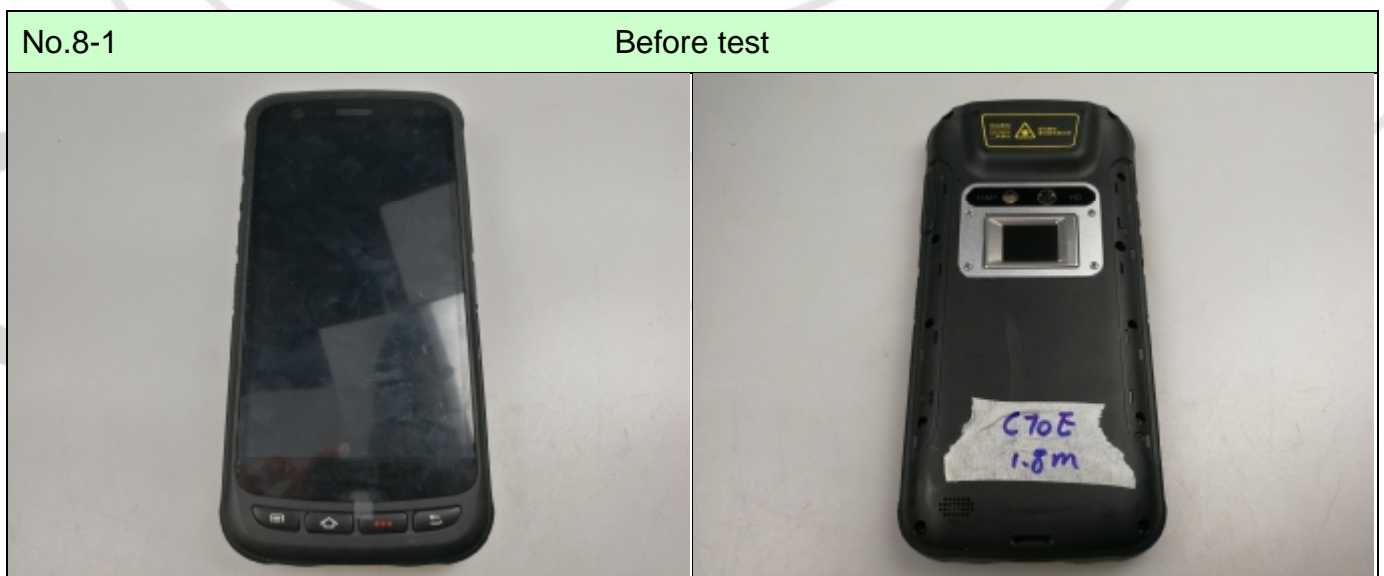
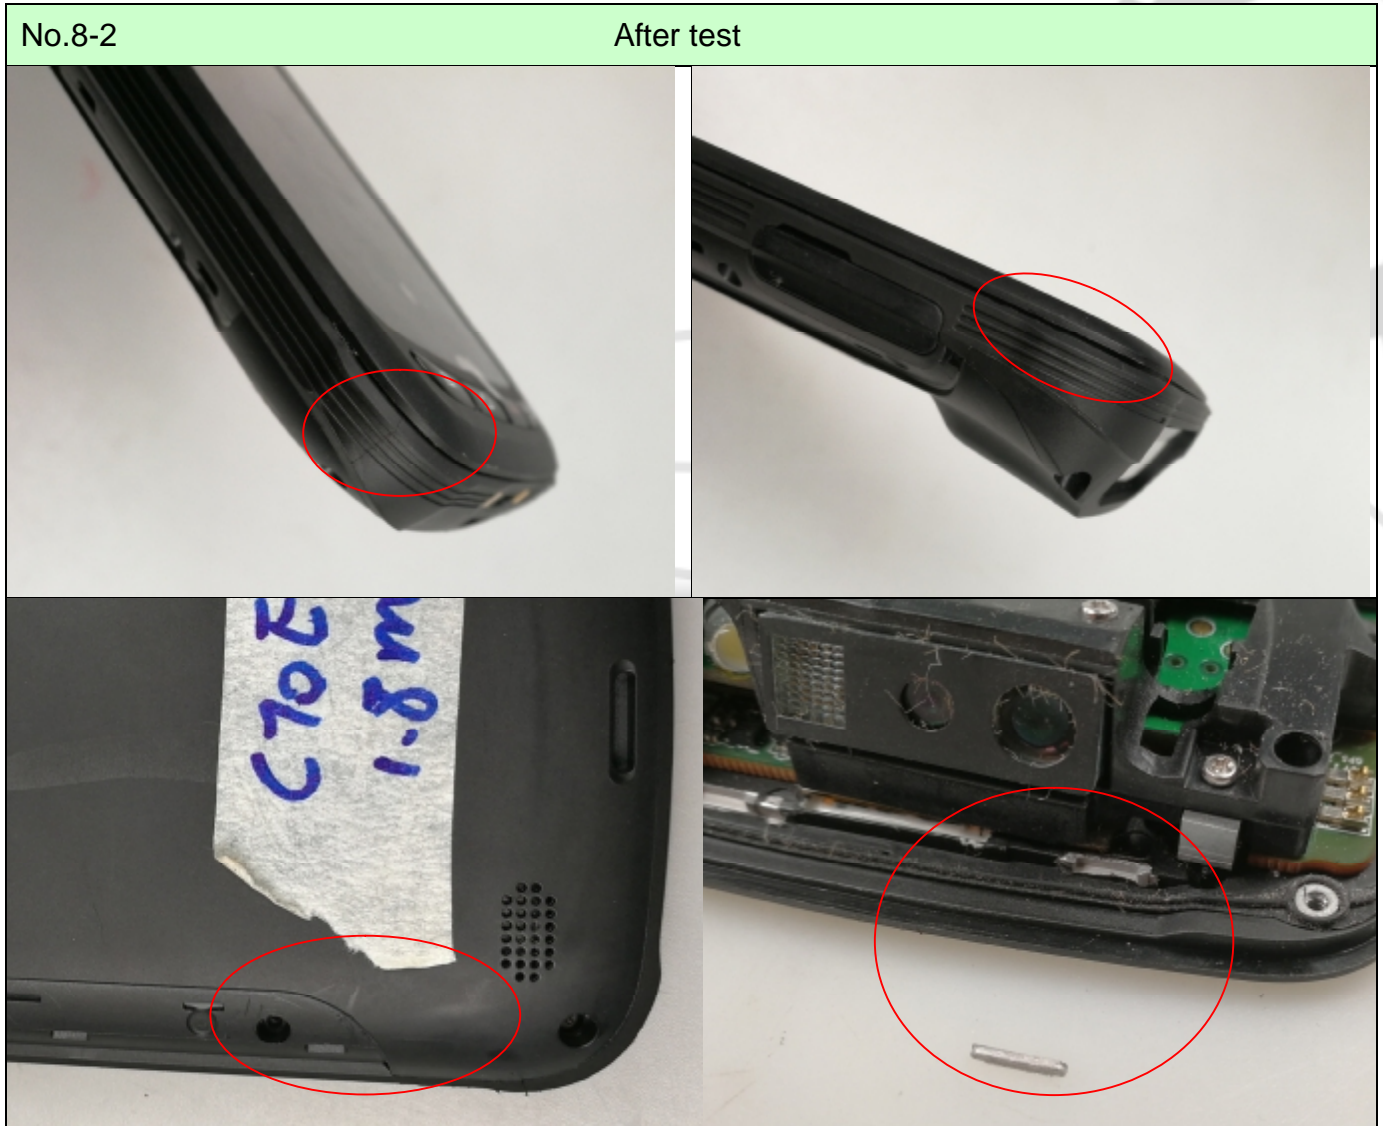
8. Test Photo:

No.	Test part	Test Symptom		
		1cycle	2cycle	3cycle
LHJ1700856_1-01#	rear	No damage	Right side cover scratch	No damage
	front	No damage	No damage	No damage
	left	No damage	No damage	No damage
	right	No damage	No damage	No damage
	top	No damage	Left bottom corner appears gap	No damage
	bottom	No damage	No damage	No damage
	left	No damage	/	/
	right	Right upper corner appears gap	/	/
	Plastic inside of the shell fell off after 20 times
