Test Report

Description: Mobile Data Terminal

Model/Type: C70S

- I Drop Test

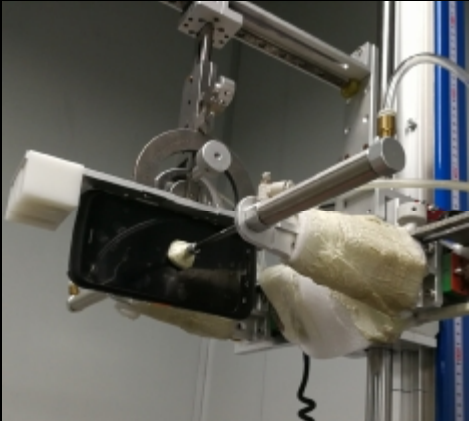
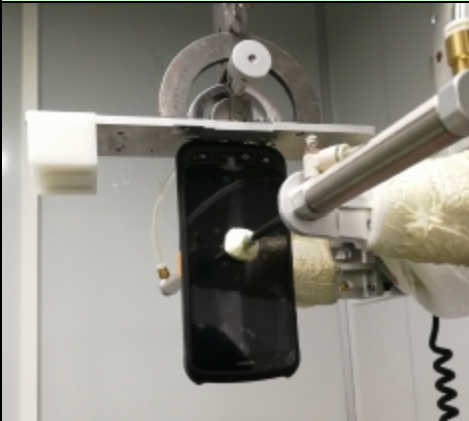
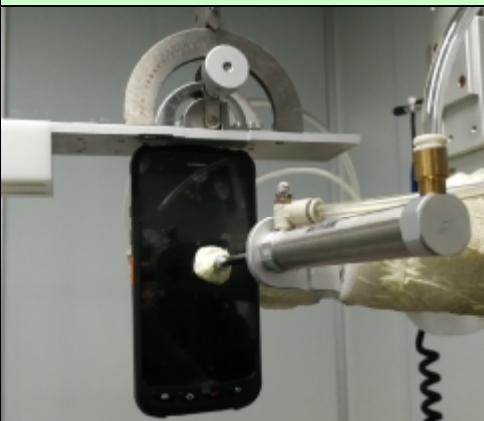
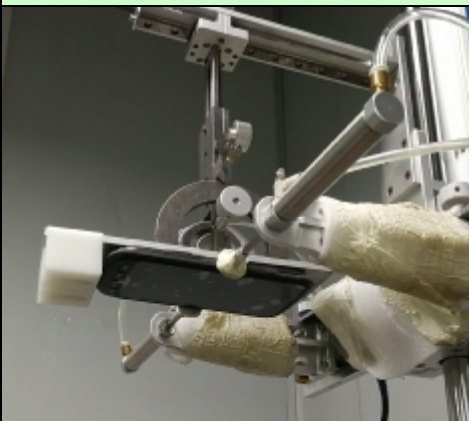
No.6-1 Test Setup	
rear side	left side

- I Drop height: 1.8m.
- I Drop plate: marble
- I Drop sequence :
 1. A flat drop on the rear side
 2. A flat drop on the left side
 3. A flat drop on the right side
 4. A flat drop on the top side
 5. A flat drop on the bottom side
 6. A flat drop on the front side
 7. Repeat procedure 1-6 for 3 times
 8. A flat drop on the left side for 1 time
 9. A flat drop on the right side for 1 time

- I Refer to IEC 60068-2-31 (2008).
- I The photos of sample are shown as below:

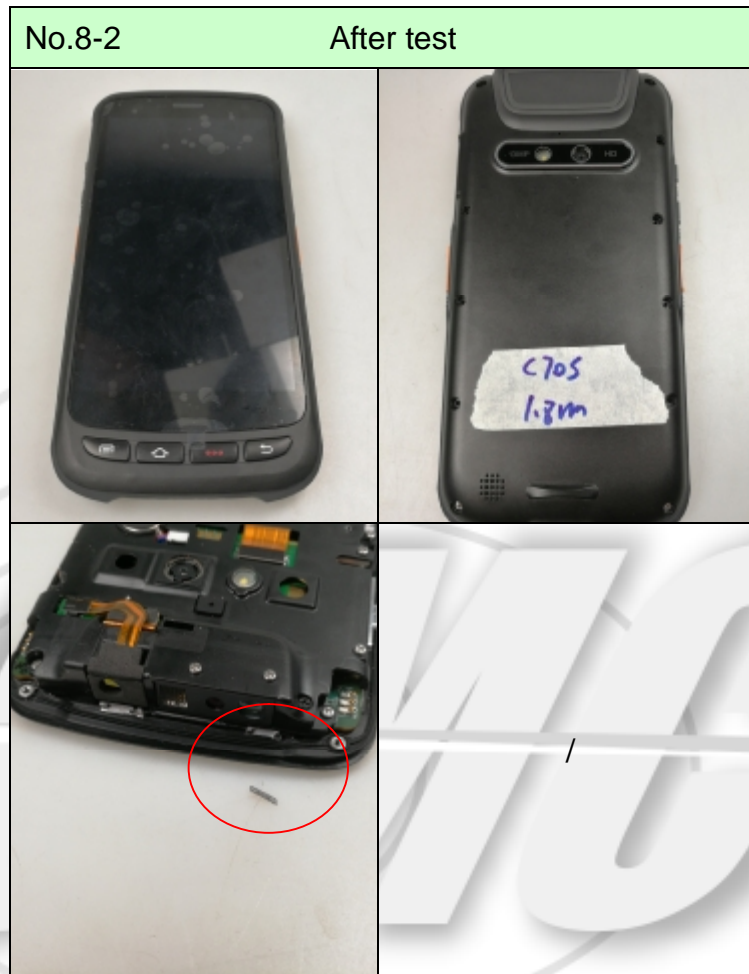
8. Test Photo:

No.	Test part	Test Symptom		
		1cycle	2cycle	3cycle
LHJ1700860_1-01#	rear	No damage	No damage	No damage
	left	No damage	No damage	No damage
	right	No damage	No damage	No damage
	top	No damage	No damage	No damage
	bottom	No damage	No damage	No damage
	front	No damage	No damage	No damage
	left	No damage	/	/
	right	No damage	/	/
	Plastic inside of the shell fell off after 20 times
